## IMPORTANT

Land Cruiser 70, 80, 100 Series

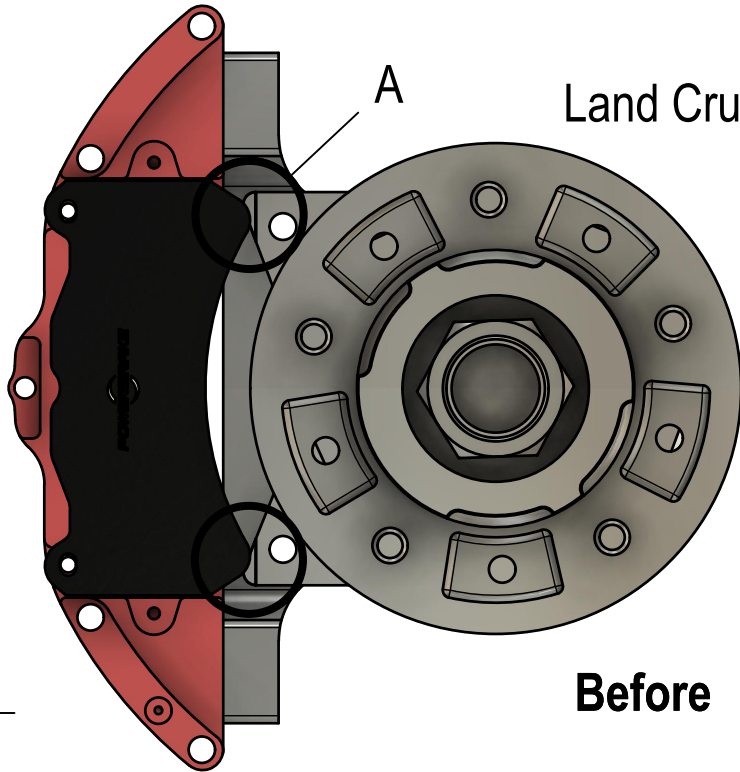
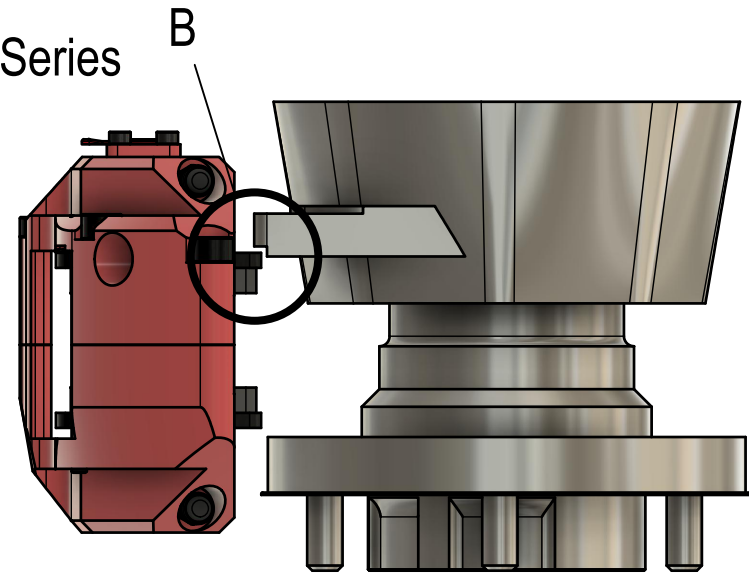
A (1:1)

Before

On some year models of Landcruiser the knuckles protrude further and may require slight grinding to clear the bottom of the pads in the Powerbrake caliper. Check carefully if grinding is required on **BOTH** knuckles before tightening the caliper to the bracket.

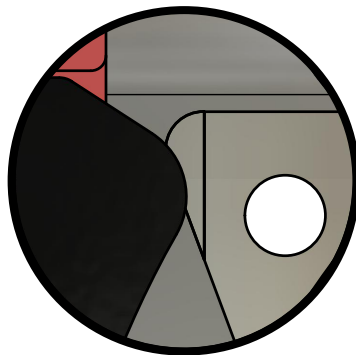
B (1:1)

After

Only grind what is necessary!
